**Embankment Criteria and Performance Report**

# **JOE POOL LAKE MOUNTAIN CREEK, TEXAS** TRINITY RIVER BASIN

**OCTOBER 1991**

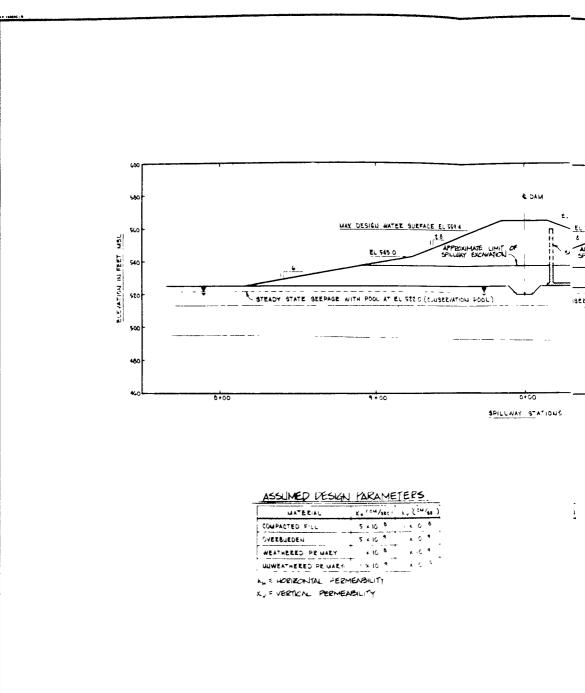
MAG # EL 5645 - EL 559 4 APPROXIMATE LIMIT OF SAUD DEA HAGE EL 543 0 MATURA, GROUND E. SES I SERVATION FOOL DVERSURDEN APPLIMATE LIMIT OF SPIELWAY EXCAVATION NEAT IEREU PR MARY UNWEATHERED PRIMARY 11+00 10+00 SPILLARY STATIONS HOTES LOCATION OF THEFARE LINE WAS ESTIMATED US US TIMITE ELEMENT COMPUTER ANALYS & CONDUCTED AT ILES 2 NATURAL GROUND ELEVATION AT THE LEFT EMBANGMENT NO 2 APPROXIMATELY E 515 S ABOVE CONSERVATION POOL EL 822 C Mer./1.15 MEP

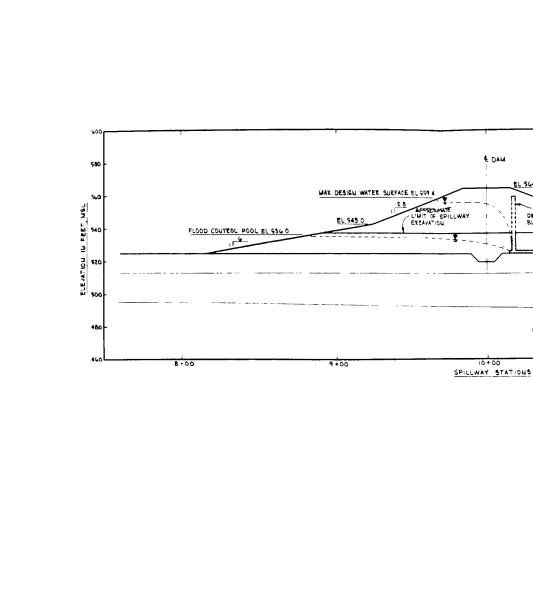
& DAM EL 564 5 SURFACE EL 559 4 SAUD DRAINAGE BLANKET APPROLIMATE LIMIT OF SPILLWAY EL 545 0 EXCAVATION COMPACTED FILL -NATURAL GROUND EL SES ± OVERBURDEN APPROXIMATE LIMIT OF SPILLWAY EXCAVATION WEATHERED PRIMARY UNWEATHERED PRIMARY 12 + 00 10+00 11+00 SPILLWAY STATIONS HOTES LOCATION OF SEPROSE LIKE DETERMINED USING FINITE ELEMENT ANALYSES CONDUCTED AT WES Z SEE PLATE FOR A TABULATION OF ASSUMED PERMEABILITIES 5 DEVELOPMENT OF THE GESPAGE LINES SHOWN IS HIGHLY UNLIKELY DUE TO THE SHORT DURATION OF THE POOLS THE MPERVIOUS LATURE OF THE EMBANGMENT MATERIALS AND THE RELAY JELY COURS SEPAGE PATHS, & THE COUD TOURS SHOWN ON PLATES AND ARE MORE APPROPRIATE FOR DESIGN

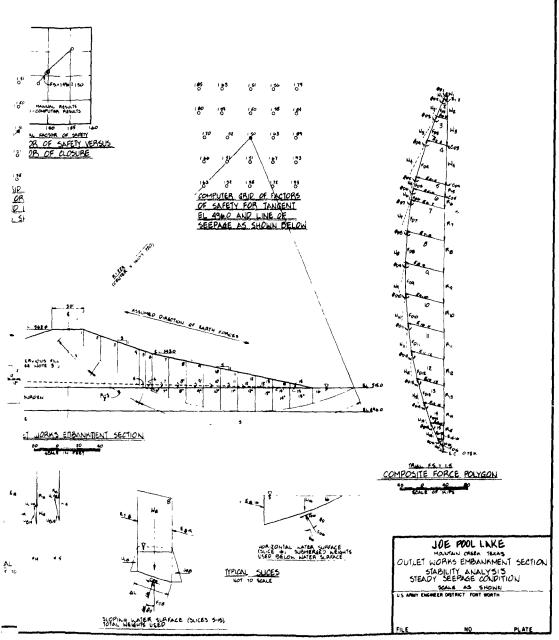
PLATE 60

TOTAL VICE US ARMY ENGINEER DISTRICT FORT CORPS OF ENGINEERS FORT WORTH TEAMS JOE POOL LAKE EMBANKMENT AND SPILLWAY OUTLET WORKS EMBANKMENT SECTION STABILITY ANALYSES
WEDGE METHOD
WEDGE METHOD
OF CONSTRUCTION COMDITIONS WITH
SO WEXCESS PORE PRESSURE IN FOUNDATION 184 MO DATED

R-strength. The phreatic surface was conservatively simulated as a straight line from its entry point to the downstream toe. The minimum factor of safety calculated by the computer and manual methods was 1.50 for a circle passing tangent to the base of the foundation overburden (plate 60). A local minimum factor of safety of 1.53 was also calculated for a circle passing tangent to the base of the embankment.

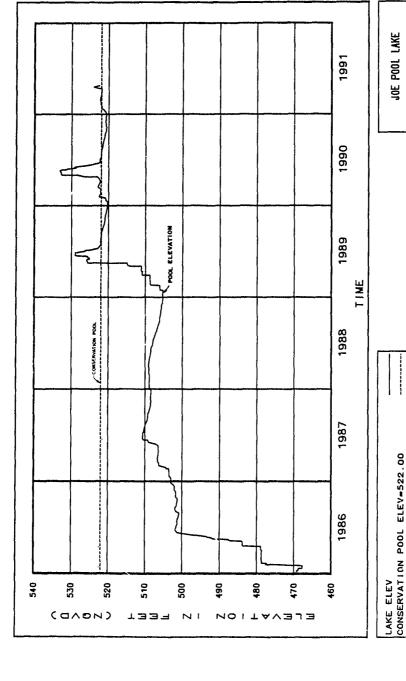
PLATE 82

FORT WORTH DISTRICT LAKE ELEV. VS. TIME

a. General. - There were a total of 18 porous plastic tip piezometers installed by Government forces during construction of this project Plates 80, 81 and 98 through 100 provide information on the location, filter elevation, and design of the piezometers. This type of piezometer has been used on numerous projects throughout CESWF and has proven to function well in a variety of materials including clay shales, granular and high plasticity clay materials The piezometers were installed to monitor any excess pore pressures developed in response to fill placement, and any seepage pressures after impoundment. Excess pore pressure in this report is defined as the ratio of increased piezometric pressure above natural ground to the increased foundation pressure due to fill at that location, expressed as a percentage Piezometers were installed along four sections in the floodplain and at the spillway Readings of these instruments were taken by the contractors on a weekly basis, while the Government verified the readings at random. Since completion, the piezometers have been read on a quarterly basis. All other instrumentation is being read annually Pool elevation vs time is presented on plate 82 Analyses of the piezometer readings are presented in the

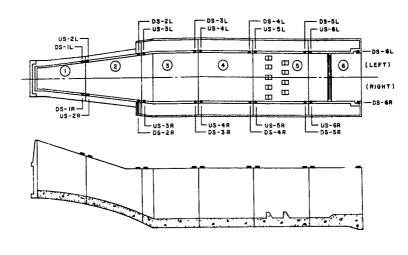
JOE POOL LAKE
STILLING BASIN WALL REFERENCE MARKS
Outlet Works

HORIZONTAL MOVEMENT (Distance Between Points)						
DATE	DS-1L TO DS-1R	US-2L TO US-2R	DS-2L TO DS-2R			
ORIGINAL DIST						
April 86	16 25'	16 47	23 67'			
Sep 86	16 24'	16 46'	23 67'			
Feb 87	16 24'	16 47'	23 67'			
Sep 87	16 24'	16 47'	23 67'			
Feb 88	16 24'	16 46'	23 67'			
Jan 89	16 23'	1645	23 66'			
Aug 89	16 25'	16 47'	23 68'			
Feb 90	16 24'	16 46'	23 66'			
Feb 91	16 24'	16 46'	23 66'
